# **FRESHWATER ECOLOGICAL VERIFICATION ASSESSMENT FOR PORTION 18 AND PORTION 55 OF ERF 37119, IN KRAAIFONTEIN, CAPE TOWN, WESTERN CAPE PROVINCE**

**Bo Mo Property Developers (Pty) Ltd**

**August 2020**

| <b>Report reference:</b> | <b>FEN 21-0043</b> |

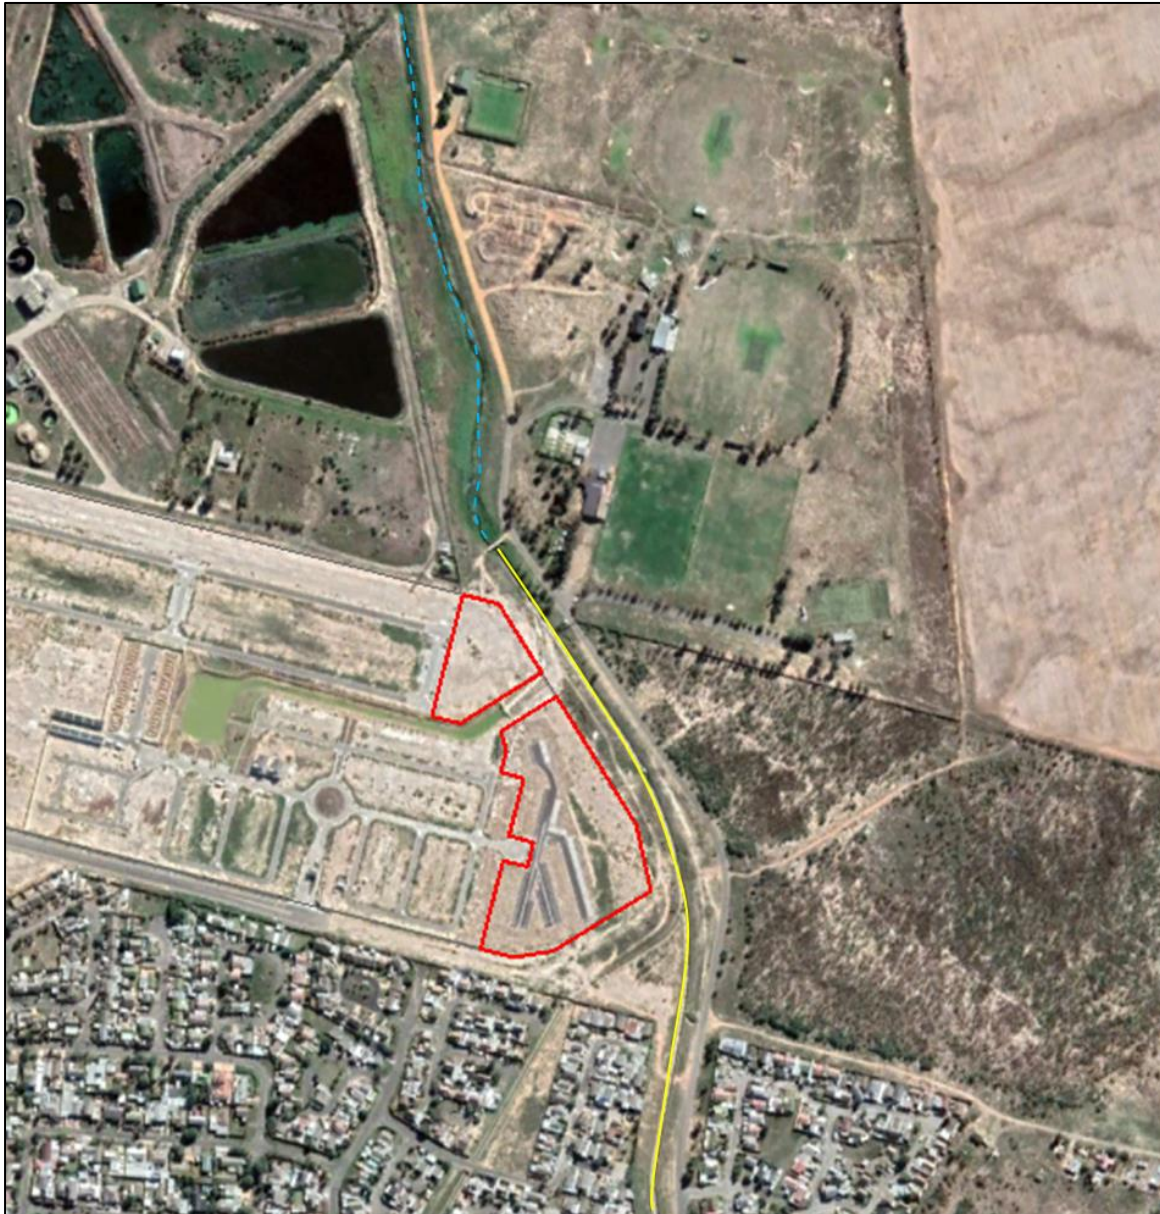
**Figure 5: Digital satellite imagery (2020) of the study area (red outline) relative to the Maarstricht canal (indicated by yellow line). The downstream reach of the watercourse is unlined (indicated by blue dashed line).**

On review of the latest digital satellite imagery circa 2020 (Figure 5), it is evident that the surrounding land uses have significantly transformed from the historical agricultural practices to peri-urban, with specific mention of current construction activities within the western portion of the study area. The area to the east of the study area remains predominantly agricultural. The upstream reach of the watercourse associated with the study area as per the historical imagery has also been straightened and formalised into a concrete lined channel, referred to as the Maarstricht canal (Figure 5). The downstream reach thereof, adjacent to the Kraaifontein Waste Water Treatment Works is still unlined.

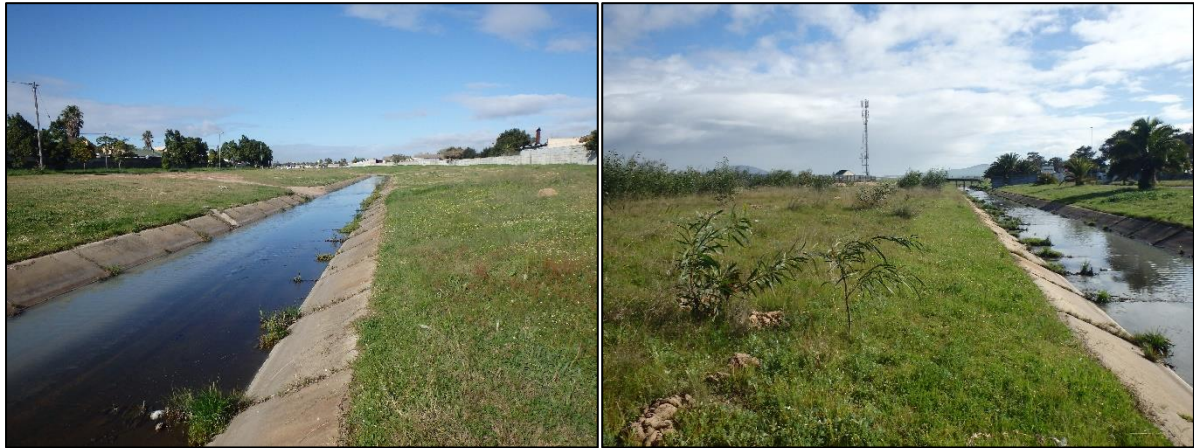
**Figure 9: Photographs depicting the Maarstricht canal associated with the study area.**

3. No obligate or facultative wetland or riparian vegetation was noted within the Maarstricht canal or the open space area between the edge of the canal and the boundary fence of the study area, only graminoid species such as *Pennisetum clandestinum* (kikuyu grass) and *Acacia saligna* saplings (Figure 10) were observed. This vegetated strip between the canal and boundary fence is approximately 22 m in width. The area below the 1:100 year floodline within the study area is also well vegetated with a variety of terrestrial vegetation species (Figure 10). Although the Maarstricht canal is considered a watercourse from a legal perspective, the canal does not provide any significant ecological service other than hydrological connectivity and recharge to the downstream Mosselbank River (i.e. streamflow regulation), and flood attenuation.

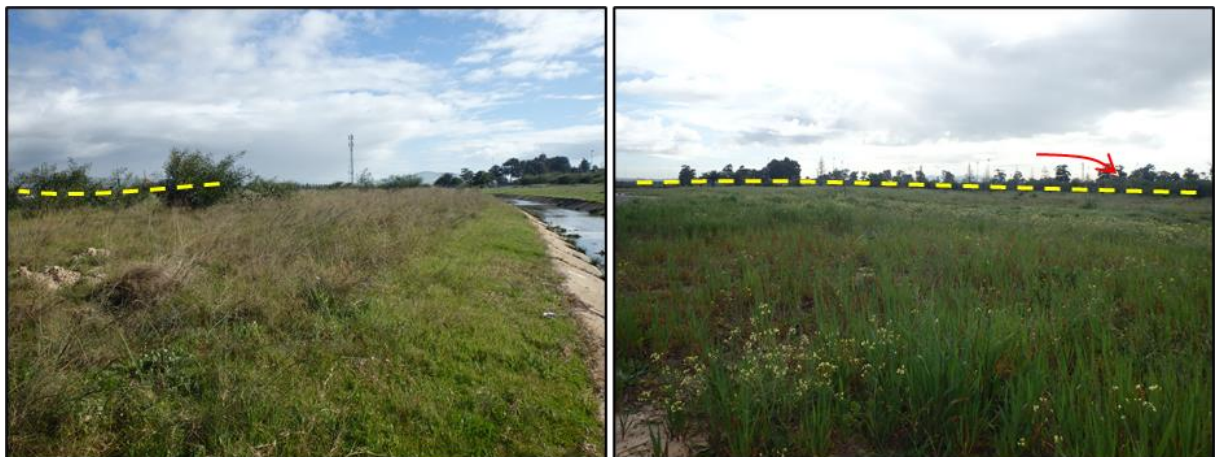
**Figure 10: Photographs depicting the vegetation of the area between the canal and the study area boundary indicated by the yellow dashed line (left) and the area below the floodline in the study area up to the boundary fence (yellow dashed line)(right). The Maarstricht canal is located east of the boundary fence (yellow dashed line).**
